# **Tiger Creek Burned Area Emergency Response Hydrology Report**

***Umatilla National Forest***

**Rory Corrigan, Umatilla National Forest  
October 2024**

## **REPORT SUMMARY (SECTION G OF THE 2500-8)**

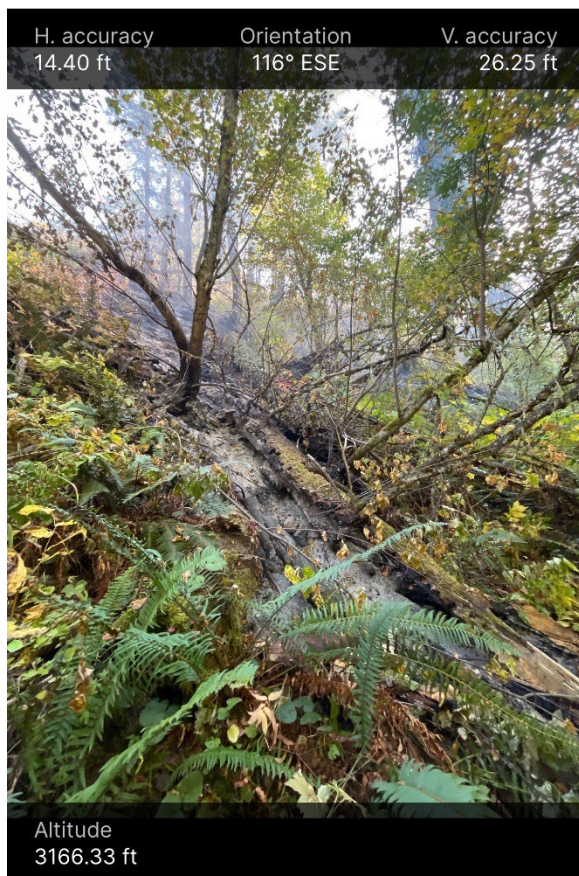
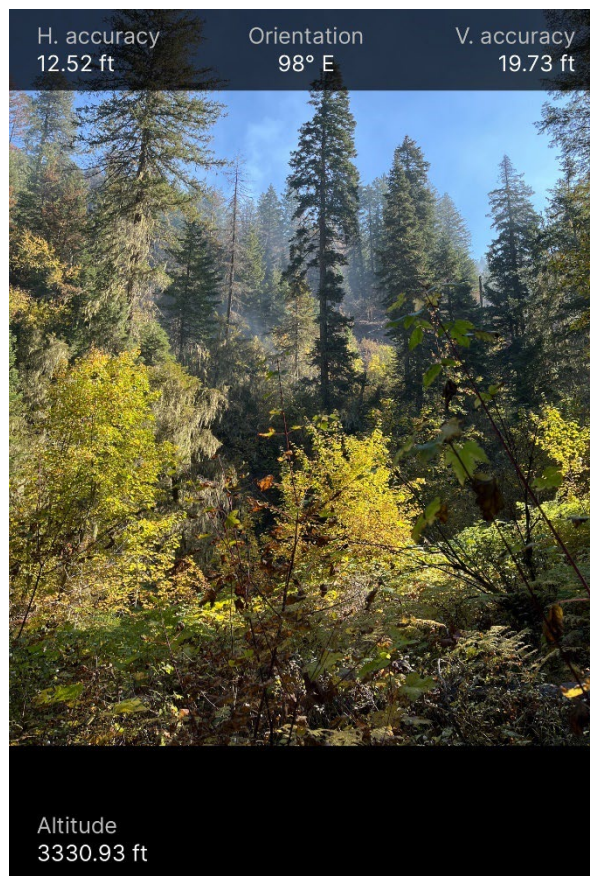
*Burn looking upslope from Tiger Creek; dominant condition on the right; area of burn in riparian area on left*

**Field Observations:** The portion of the fire between Tiger Creek and Forest Service Road 65 burned primarily on the mid to upper portions of the slopes and effects were aligned with expectations from prescribed fire. Basal area mortality is anticipated to be more moderate overall with pockets of higher mortality on the steeper portions of the slopes closer to the road. Fire appeared to have backed into the riparian area stopping at the toe of the valley slope. There were two spots noted where burns extended into the riparian valley floor in the footprint of fallen trees and burned to roughly 25 feet from the ordinary high-water line. Ground cover on the burned upland area was moderate with needlecast present and potential for more, as well as pockets of shrubs remaining unburned. No hydrophobic soils or significant stretches of ash pockets were observed. Riparian vegetation and canopy cover was almost entirely intact.

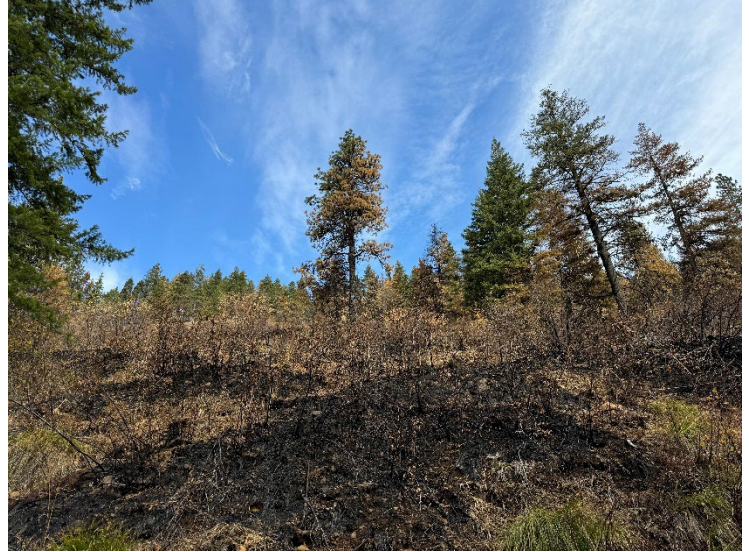
*Mid-slope burn area condition in Tiger Creek drainage, timber stringer left, exposed grass and shrub dominated slope right.*
